magicolor[®] 330

Service Manual

November 2000
1750049-001B

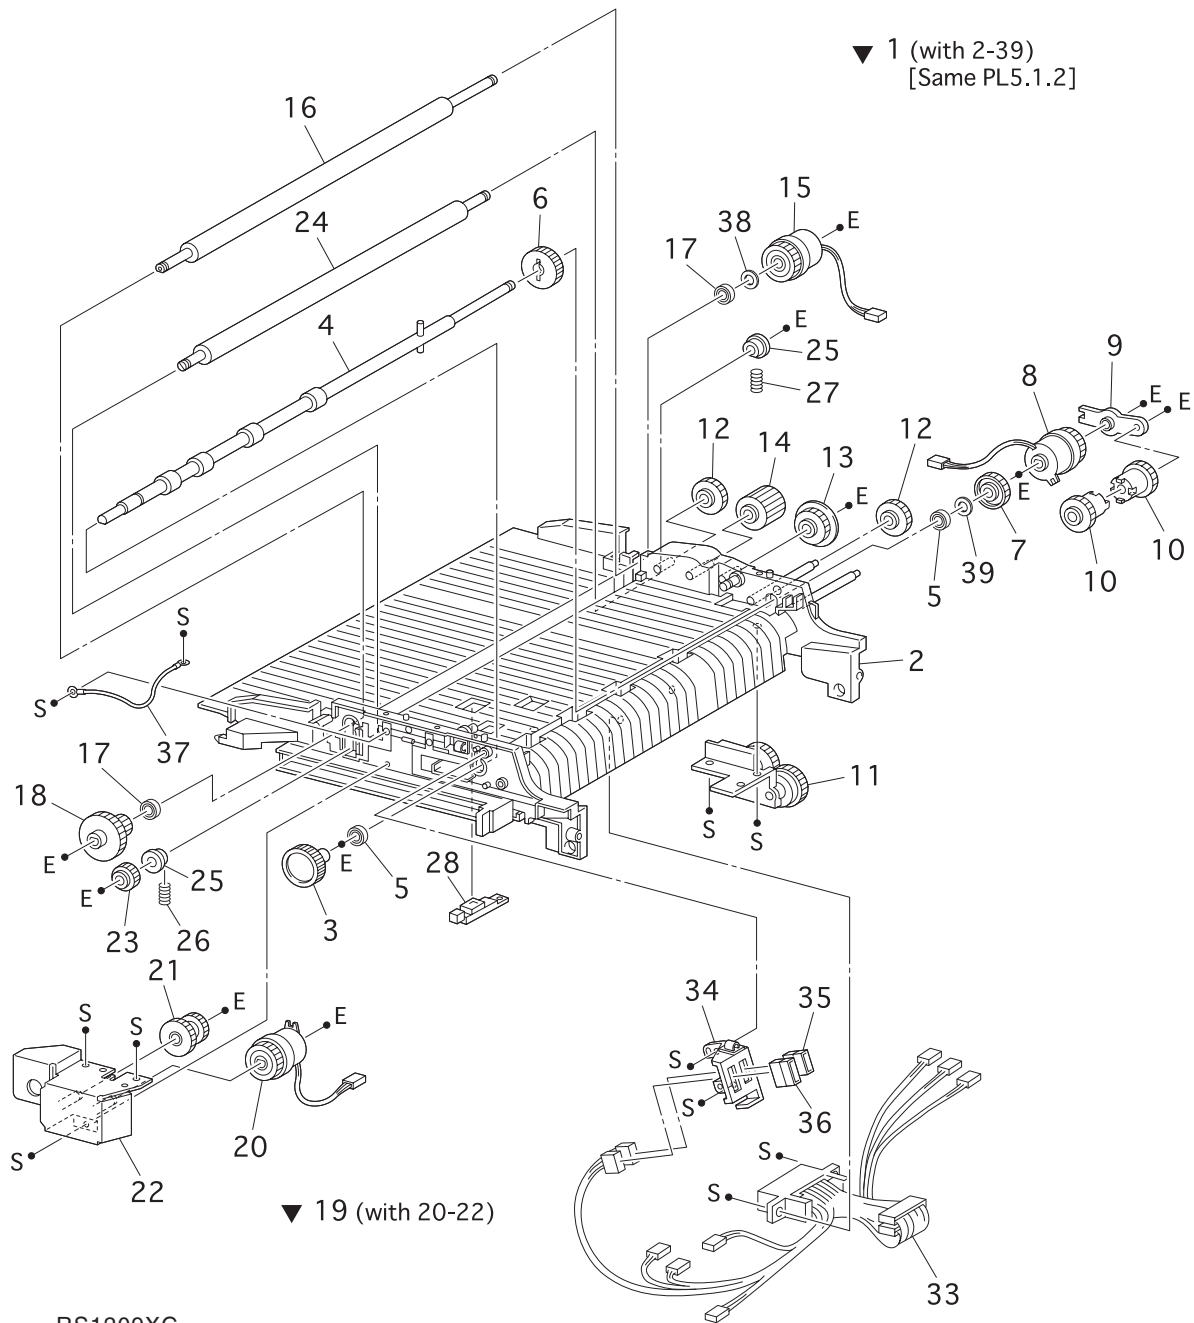
PL5.2 Paper Transportation II

1. MAIN P/H SUB ASSEMBLY (with 2~39) - (Same as PL 5.1.2).....	N/A
2. P/H FRAME ASSEMBLY	N/A
3. PRE-REGISTRATION KNOB ASSEMBLY	P/N 865003E37710
4. PRE-REGISTRATION ROLL ASSEMBLY	P/N 865059K04760

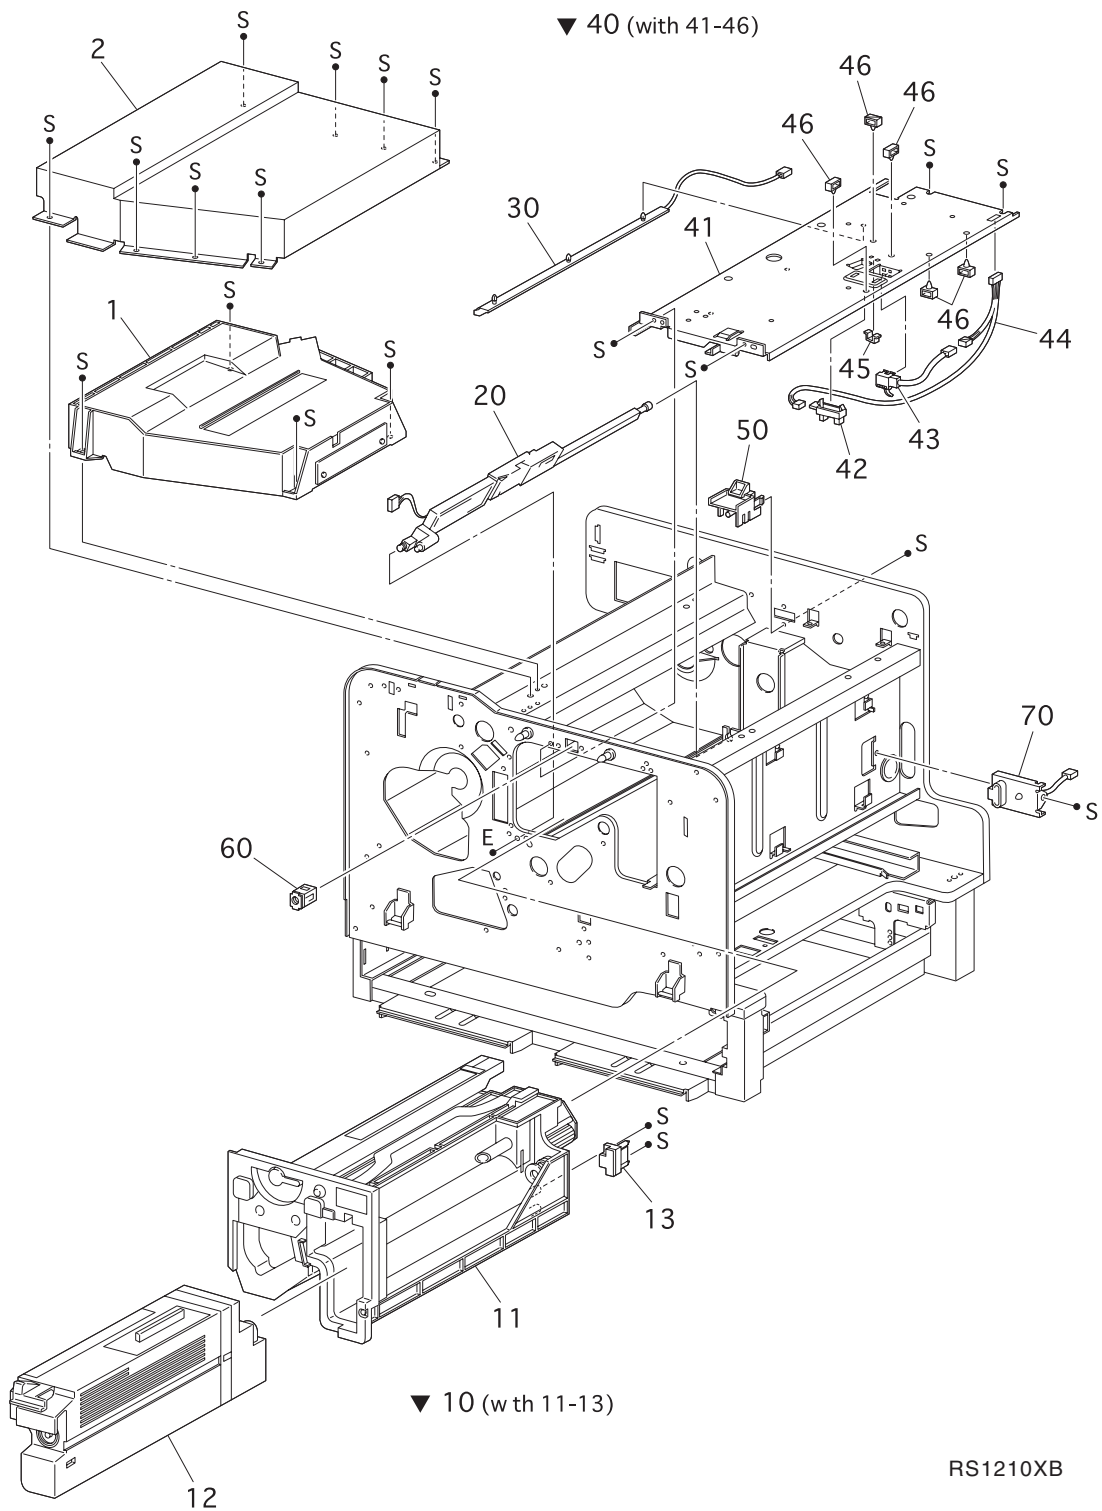
PL6.1 Xerographics

1. ROS ASSEMBLY	P/N 865062K98331
2. ROS COVER	N/A
3. ROS PLATE	N/A
10. DRUM CARTRIDGE (with 11 ~ 13)	P/N 1710323-001
11. XEROGRAPHIC CARTRIDGE	N/A
12. WASTE TONER BOX	P/N 1710324-001
13. CRUM ASSEMBLY (factory installed option)	N/A
20. ADC SENSOR ASSEMBLY	P/N 865130K86322
30. ERASE LAMP ASSEMBLY	P/N 865122K92440
40. XL RAIL ASSEMBLY (with 41~46).....	N/A
41. XL RAIL.....	N/A
42. WASTE TONER SENSOR	P/N 865130E91010
43. TONER BOX SENSOR	P/N 865130E82980
44. TONER BOX HARNESS	N/A
45. RAIL CLAMP-1	N/A
46. RAIL CLAMP-2	N/A
50. BCR CONNECTOR ASSEMBLY	P/N 865600K68620
60. RECEPTACLE ASSEMBLY	N/A
70. CRUM CONNECTOR ASSEMBLY (factory installed option)	P/N 865113K81450

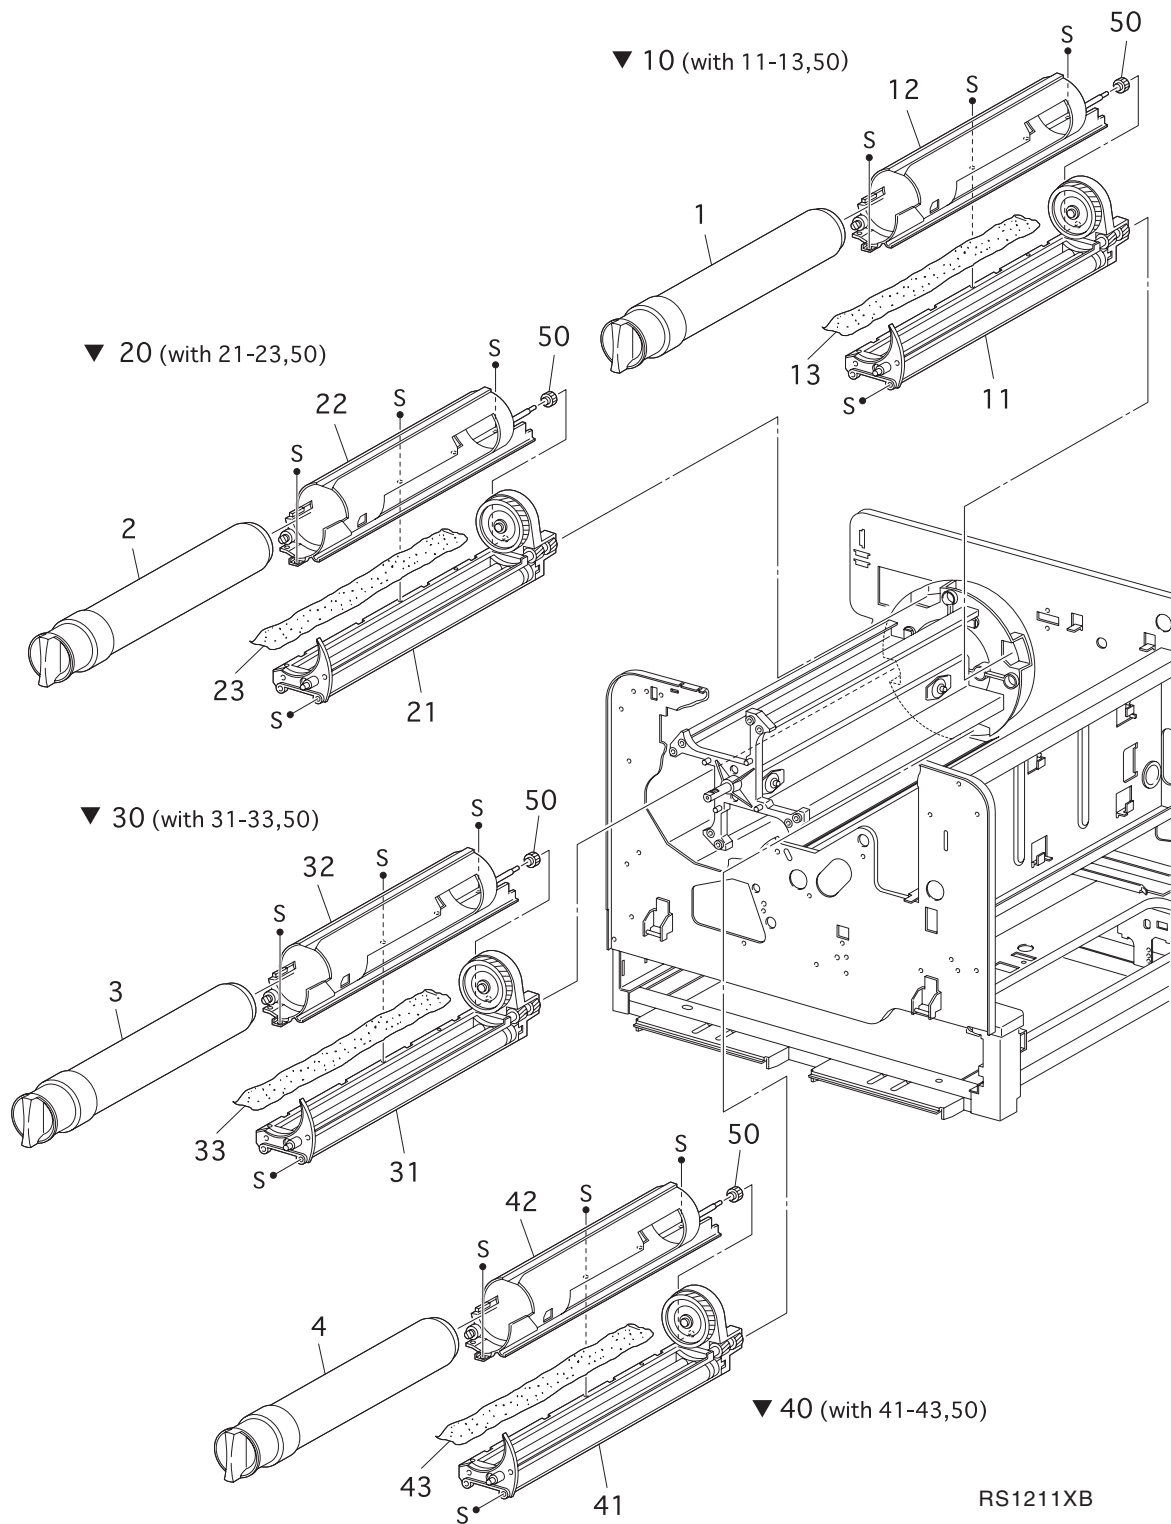
PL7.1 Development I

1. TONER CARTRIDGE Y	P/N 1710322-033
2. TONER CARTRIDGE M.....	P/N 1710322-004
3. TONER CARTRIDGE C.....	P/N 1710322-002
4. TONER CARTRIDGE BK.....	P/N 1710322-001
10. DEVELOPER ASSEMBLY Y (with 11~13, and 50)	P/N 865600K69892
11. DEVELOPER LOWER ASSEMBLY Y	N/A
12. DEVELOPER UPPER ASSEMBLY Y.....	N/A
13. DEVELOPER Y	N/A
20. DEVELOPER ASSEMBLY M (with 21~23, and 50)	P/N 865600K69902
21. DEVELOPER LOWER ASSEMBLY M	N/A
22. DEVELOPER UPPER ASSEMBLY M.....	N/A
23. DEVELOPER M	N/A
30. DEVELOPER ASSEMBLY C (with 31~33, and 50).....	P/N 865600K69912
31. DEVELOPER LOWER ASSEMBLY C	N/A
32. DEVELOPER UPPER ASSEMBLY C.....	N/A
33. DEVELOPER C	N/A
40. DEVELOPER ASSEMBLY BK (with 41~43, and 50).....	P/N 865600K69882
41. DEVELOPER LOWER ASSEMBLY BK	N/A
42. DEVELOPER UPPER ASSEMBLY BK	N/A
43. DEVELOPER BK	N/A
50. AUGER DISPENSE GEAR.....	N/A

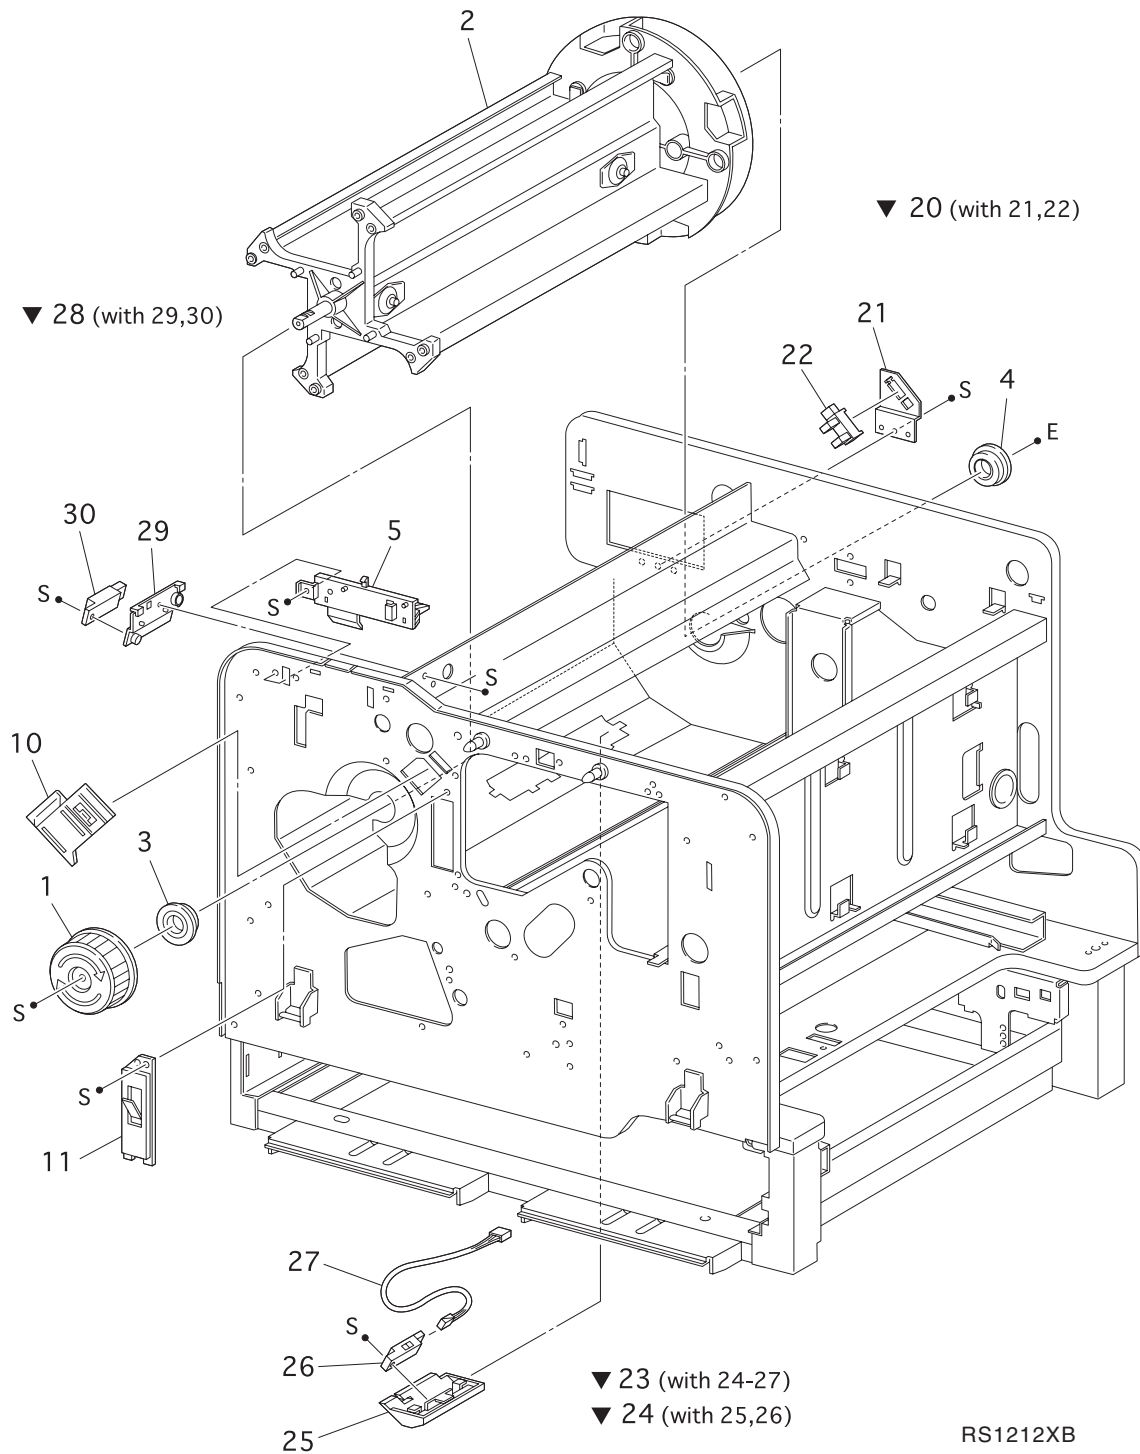
PL7.2 Development II

1. ROTARY KNOB ASSEMBLY	P/N 865003K84303
2. ROTARY FRAME ASSEMBLY	N/A
3. ROTARY FRONT BEARING	N/A
4. ROTARY REAR BEARING	N/A
5. ROTARY LATCH ASSEMBLY	N/A
10. DEVELOPER DISCHARGE ASSEMBLY	N/A
11. DEVELOPER CONTACT ASSEMBLY	P/N 865600K68630
20. ROTARY SENSOR ASSEMBLY (with 21 and 22).....	N/A
21. ROTARY SENSOR PLATE	N/A
22. ROTARY SENSOR	P/N 865130E83060
23. CARTRIDGE SENSOR H ASSEMBLY (with 24 ~ 27).....	N/A
24. CARTRIDGE SENSOR ASSEMBLY (with 25 and 26).....	N/A
25. CARTRIDGE SENSOR HOLDER	N/A
26. CARTRIDGE SENSOR	P/N 865130E83090
27. CARTRIDGE SENSOR HARNESS	N/A
28. USED SENSOR ASSEMBLY (with 29 and 30)	N/A
29. USED SENSOR PLATE	N/A
30. USED CARTRIDGE SENSOR	P/N 865130E82830

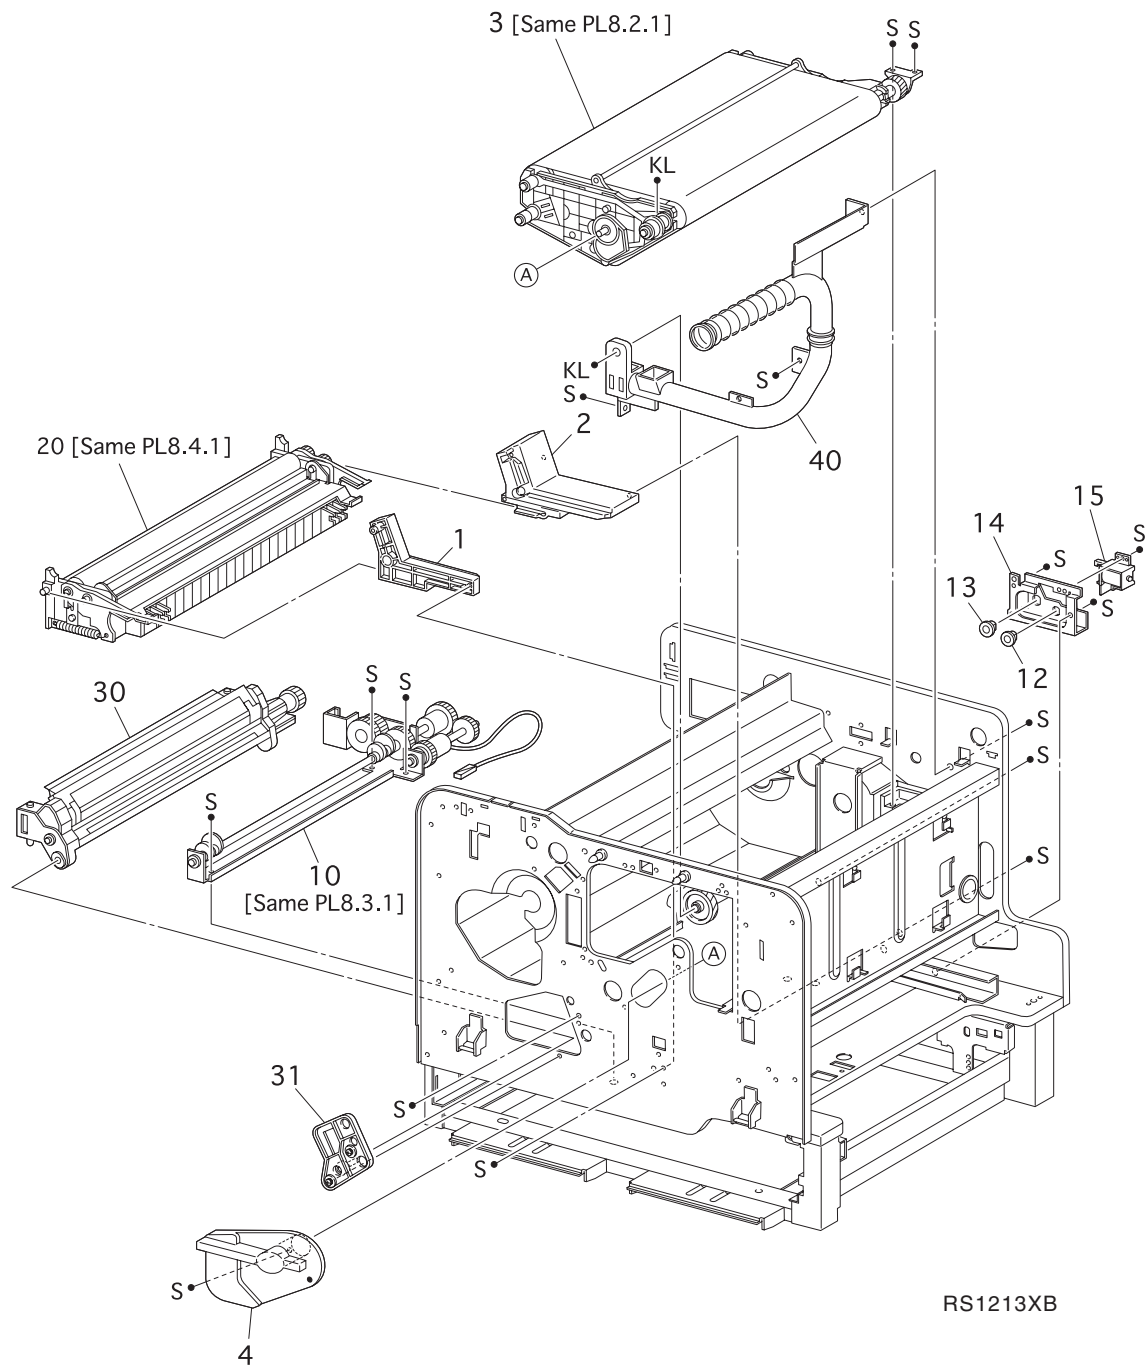
PL8.1 IBT 1

1. IBT FRONT BRACKET	N/A
2. IBT REAR BRACKET	N/A
3. TRANSFER ASSEMBLY (same as PL 8.2.1).....	P/N 865048K74572
4. TENSION LEVER	P/N 865011K94460
5. IBT BRACKET	N/A
10. 2ND BTR CAM ASSEMBLY (same as PL 8.3.1).....	P/N 865008K91354
12. BTR BEARING-4	N/A
13. BTR BEARING-6	N/A
14. BTR SIDE BRACKET	N/A
15. BTR CAM SOLENOID	P/N 865121E84291
20. 2ND BTR ASSEMBLY (same as PL 8.4.1) (mandatory replacement part)	P/N 865600K68710
30. BELT CLEANER ASSEMBLY (mandatory replacement part).....	P/N 865600K68641
31. CLEANER SUPPORT ASSEMBLY	N/A
40. AUGER HIGH ASSEMBLY	P/N 865006K82811

1. Remove the Xerographic Cartridge (RRP 9.48).
2. Rotate the Tension Lever clockwise.
3. Loosen the screw securing the Tension Lever to the IBT Push In Shaft.
4. Slide the Tension Lever off of the Shaft.

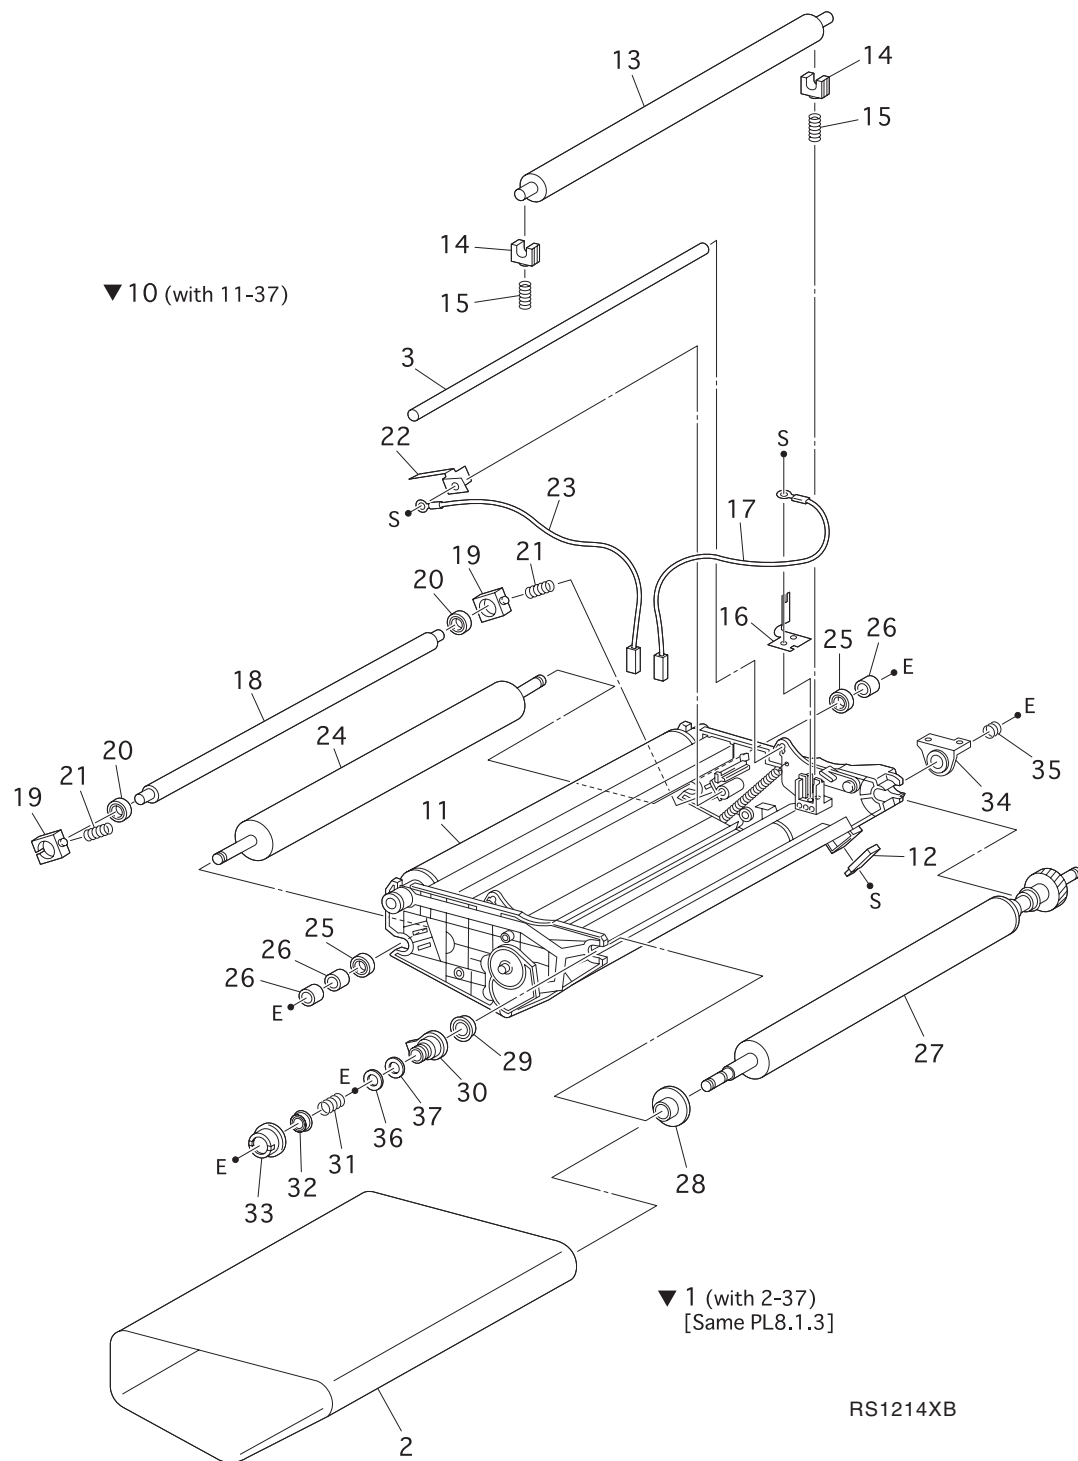
PL8.2 IBT II

1. TRANSFER ASSEMBLY (with 2~37) (same as PL 8.1.3)	P/N 865048K74572
2. IBT BELT ASSEMBLY	P/N 865064K91281
3. PUSH IN SHAFT	N/A
10. TRANSFER MECH ASSEMBLY (with 11~37).....	N/A
11. TRANSFER SUB ASSEMBLY	N/A
12. TR0 SENSOR	N/A
13. 1ST BTR	N/A
14. 1ST BTR BEARING	N/A
15. 1ST BTR SPRING	N/A
16. 1ST BTR BIAS PLATE	N/A
17. 1ST BTR WIRE	N/A
18. CONTACT ROLL	N/A
19. CONTACT ROLL BEARING	N/A
20. IBT BEARING-1	N/A
21. CONTACT ROLL SPRING	N/A
22. CONTACT PLATE	N/A
23. CONTACT ROLL WIRE	N/A
24. BACK UP ROLL	N/A
25. IBT BEARING-2	N/A
26. COLLAR-BUR	N/A
27. IBT DRIVE ROLL ASSEMBLY	N/A
28. DRIVE ROLL FLANGE	N/A
29. IBT BEARING-3	N/A
30. D/R FRONT COLLAR	N/A
31. D/R FRONT SPRING	N/A
32. IBT BEARING-4	N/A
33. SLIDE COLLAR	N/A
34. D/R BEARING ASSEMBLY	N/A
35. D/R REAR SPRING	N/A
36. IBT SPACER-1	N/A
37. IBT SPACER-2 (Use two to reduce rattle in the IBT Drive Roll Assembly).....	N/A

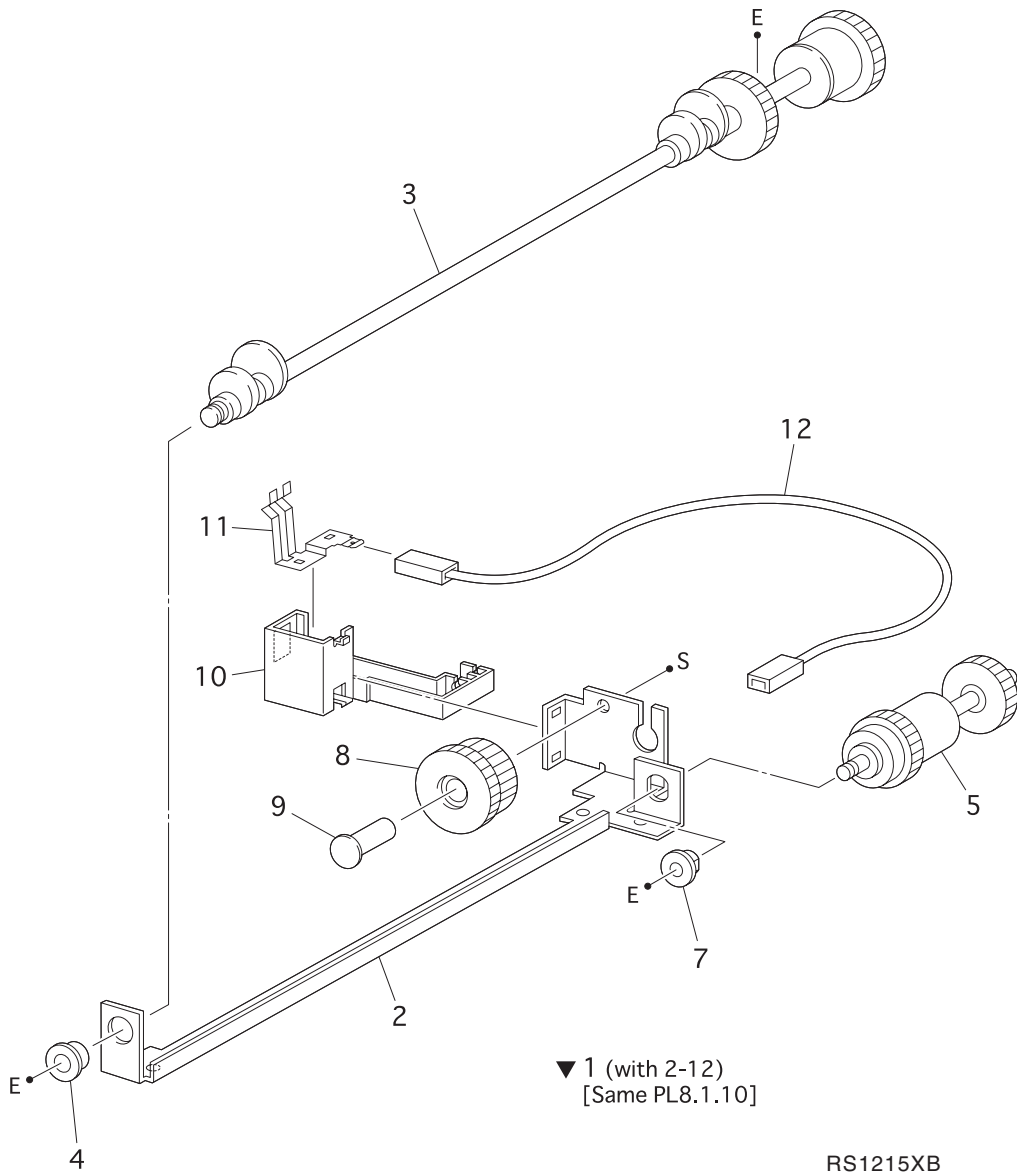
PL8.3 IBT III

1. 2ND BTR CAM ASSEMBLY (with 2~12) (same as PL 8.1.10).....	P/N 865008K91354
2. BTR CAM BRACKET.....	N/A
3. BTR CAM ASSEMBLY	N/A
4. BTR CAM BEARING.....	N/A
5. TORQUE GEAR ASSEMBLY	N/A
7. BTR BEARING-4	N/A
8. 2ND BTR GEAR B1	N/A
9. GEAR B1 SHAFT	N/A
10. DTS CONTACT HOLDER.....	N/A
11. DTS PLATE.....	N/A
12. DTS WIRE.....	N/A

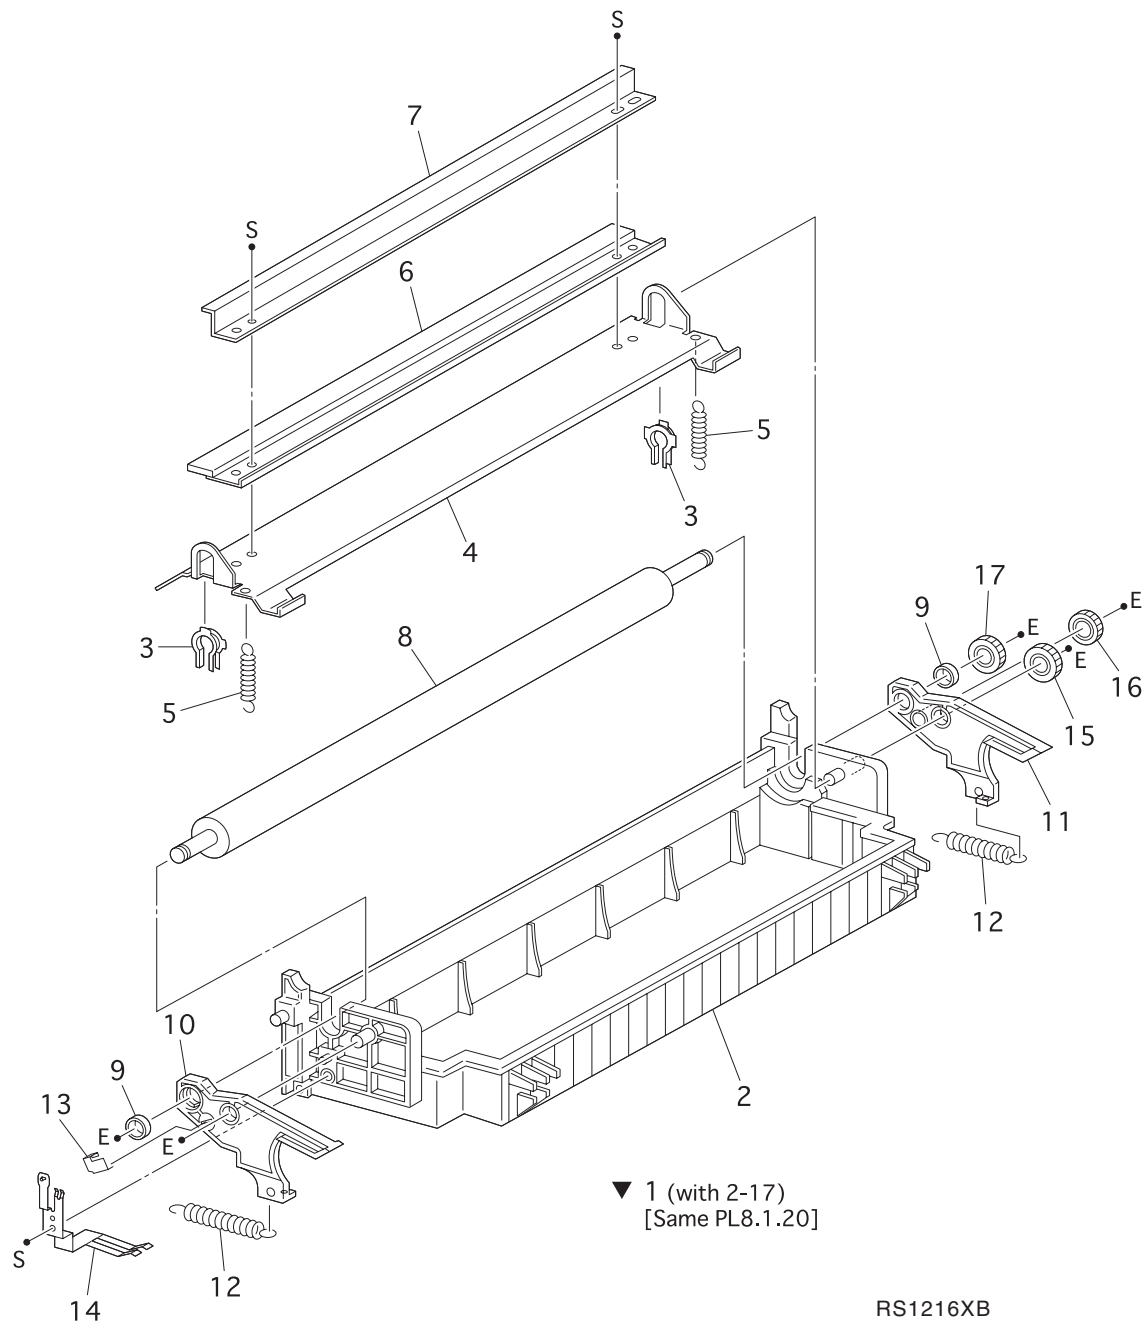
PL8.4 IBT IV

1. 2ND BTR ASSEMBLY (with 2~17) (same as PL8.1.20) (mandatory replacement part)P/N 865600K68710
2. 2ND BTR SUB ASSEMBLYN/A
3. SUPPORT BEARINGN/A
4. SUPPORT PLATEN/A
5. BTR CLN SPRINGN/A
6. 2ND BTR CLEANERN/A
7. BTR CLN BRACKETN/A
8. 2ND BTRN/A
9. 2ND BTR BEARINGN/A
10. 2ND BTR FRONT ARMN/A
11. 2ND BTR REAR ARMN/A
12. 2ND BTR SPRINGN/A
13. BTR EARTH PLATE-1N/A
14. BTR EARTH PLATE-2N/A
15. 2ND BTR GEAR A3N/A
16. 2ND BTR GEAR A2N/A
17. 2ND BTR GEAR A1N/A

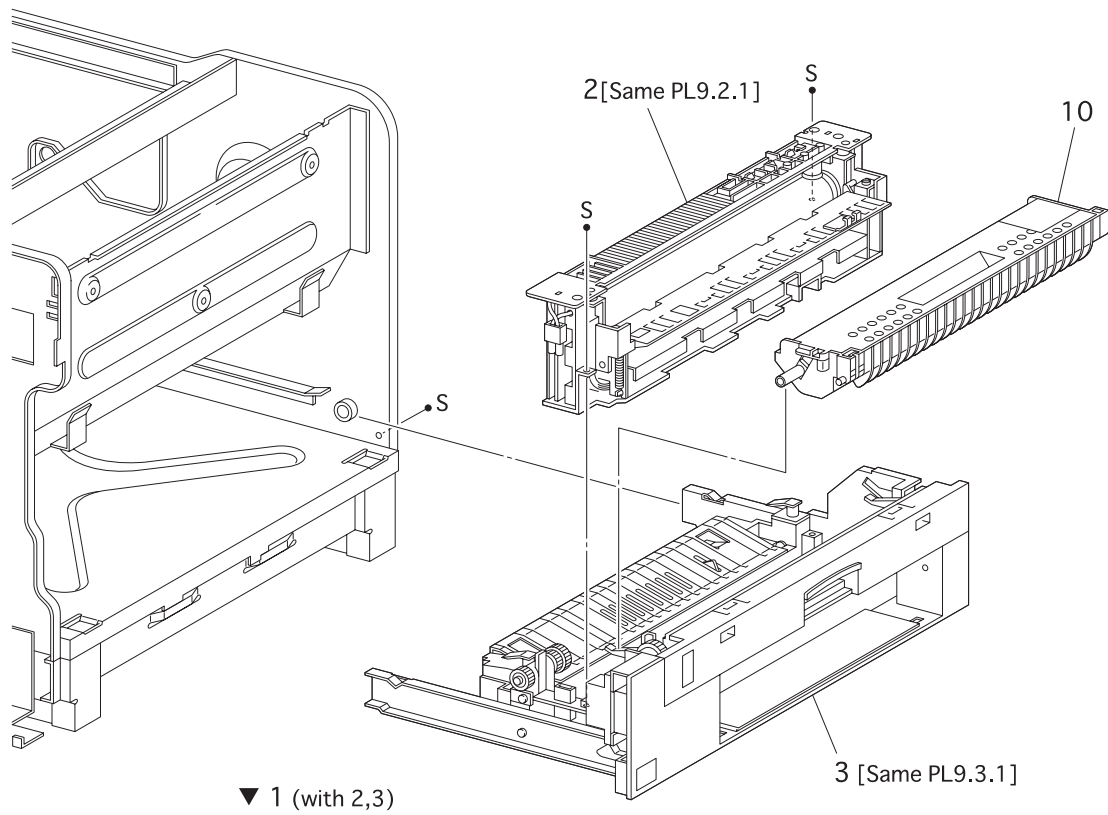
PL9.1 Fusing 1

- 1. FUSER ASSEMBLY (with 2 and 3)N/A
- 2. MAIN FUSER ASSEMBLY-110V (same as PL 9.2.1) (mandatory replacement part) P/N 865600K69992
- 2. MAIN FUSER ASSEMBLY-220V (same as PL 9.2.1) (mandatory replacement part)P/N 865600K70012
- 3. FUSER TRAY ASSEMBLY (same as PL 9.3.1)N/A
- 10. OIL ROLL ASSEMBLYP/N 1710325-001
- 10. OIL ROLL ASSEMBLY (HI-DUTY).....P/N 1710325-002

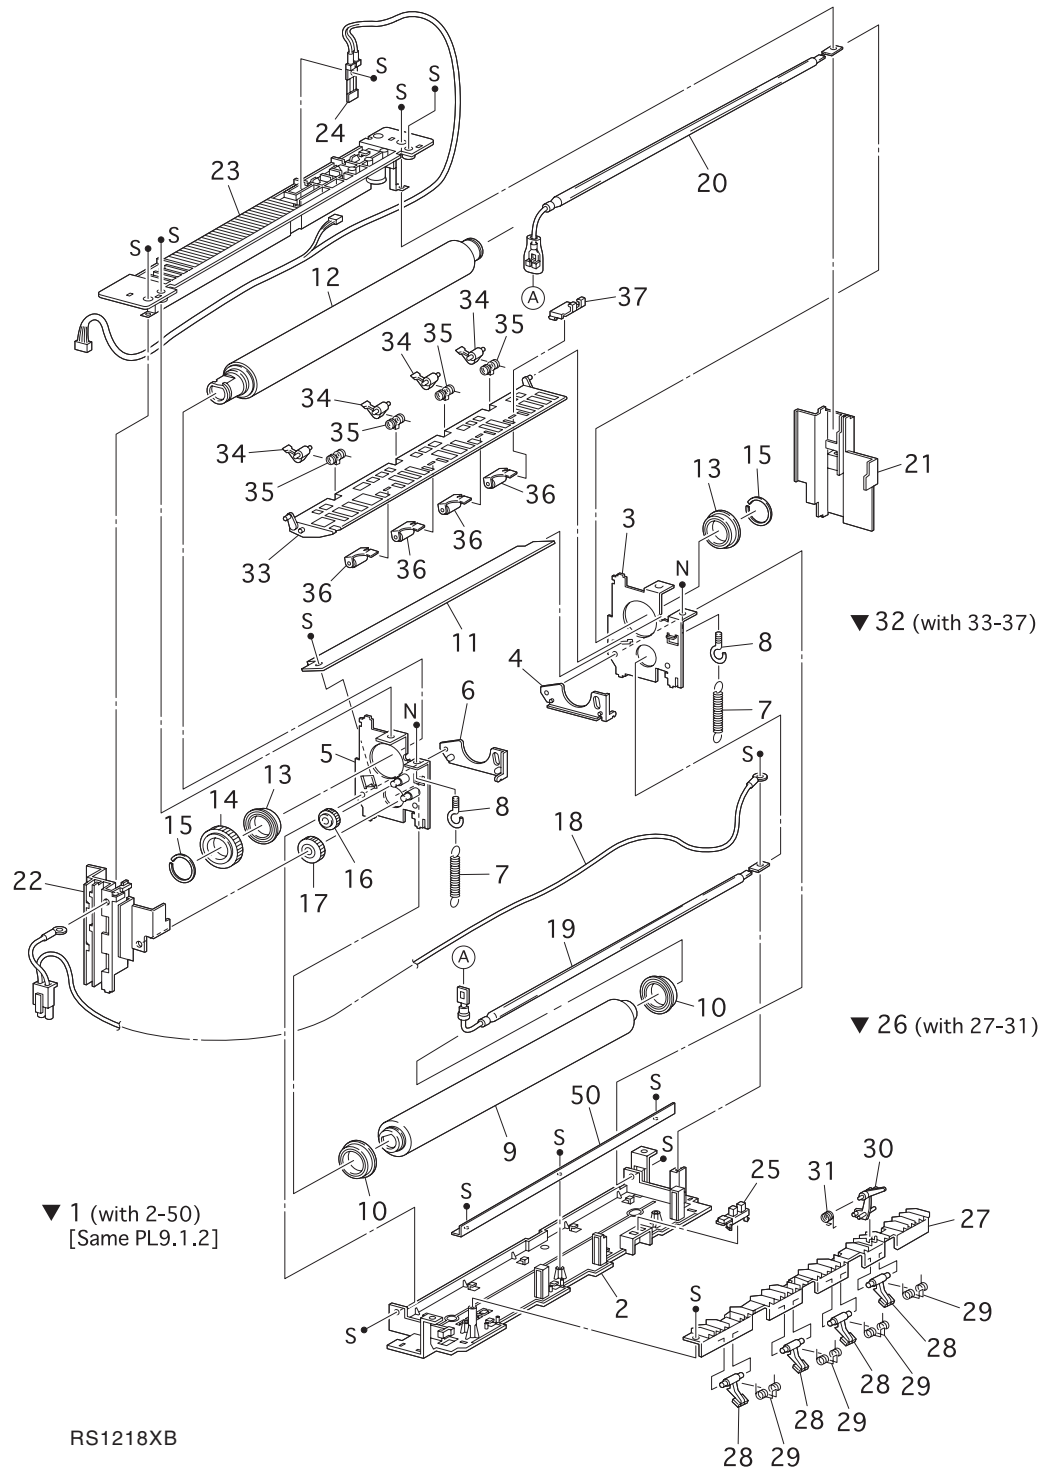
PL9.2 Fusing II

1. MAIN FUSER -110V (with 2~50) (same as PL 9.1.2) (mandatory replacement part)	P/N 865600K69991
1. MAIN FUSER -220V (with 2~50) (same as PL 9.1.2) (mandatory replacement part)	P/N 865600K70011

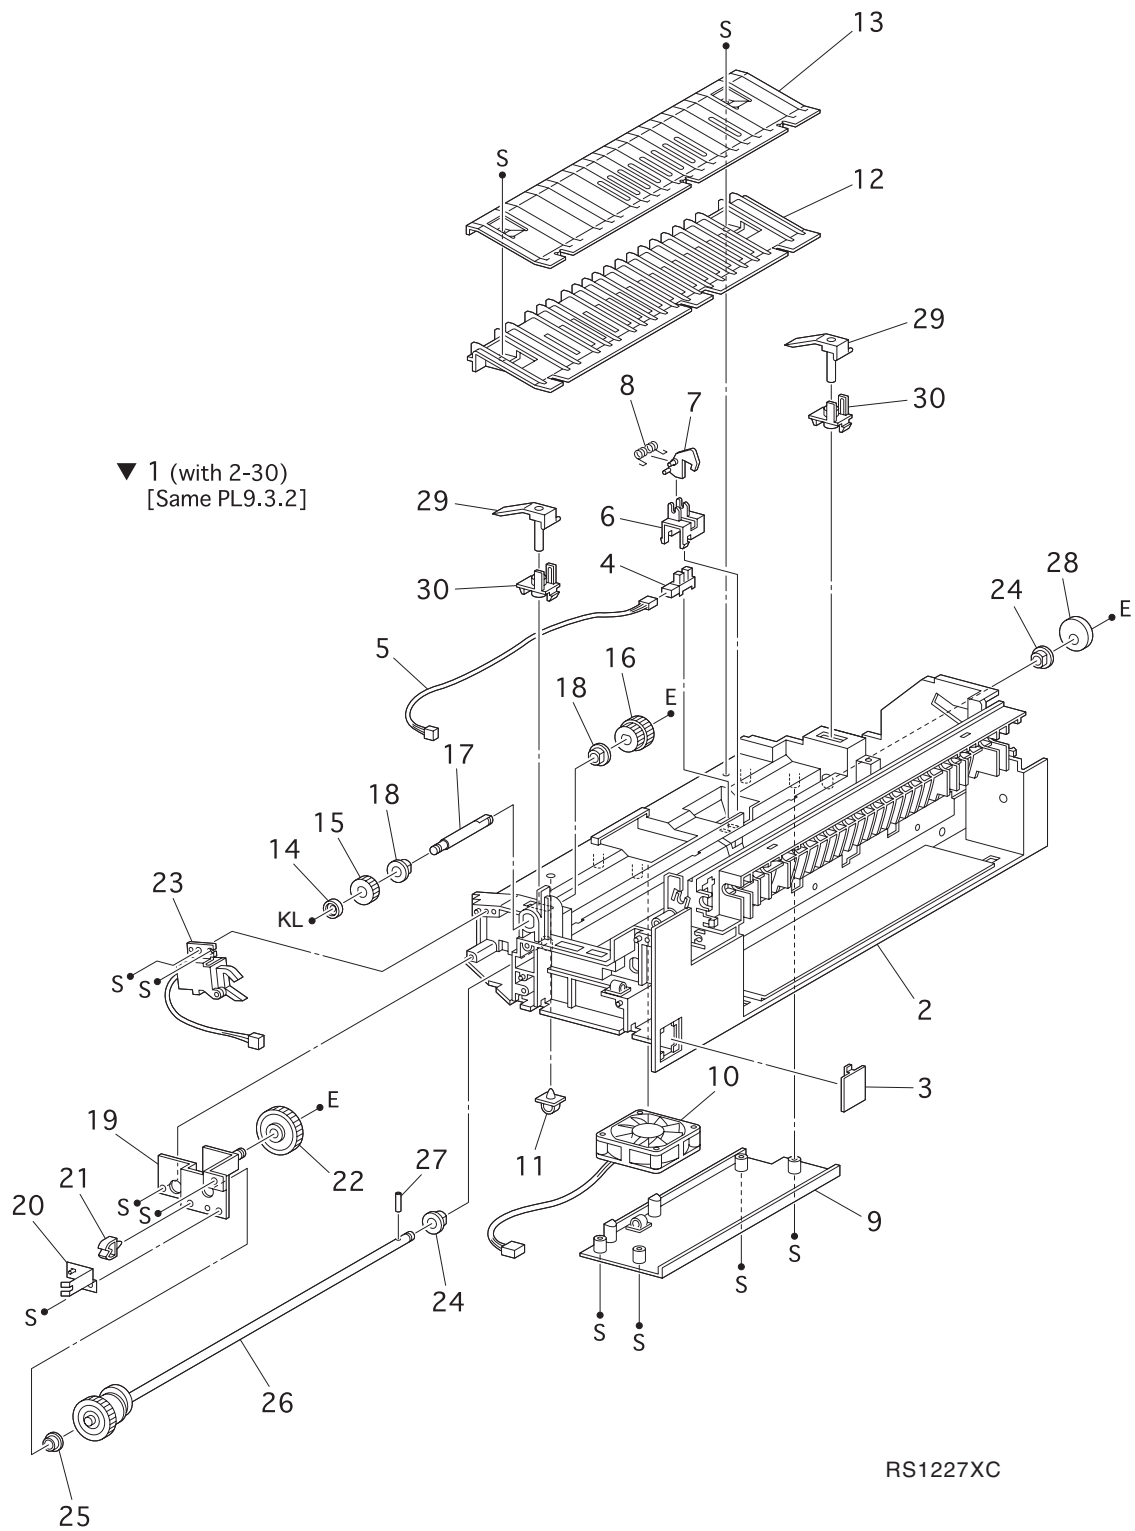
PL9.4 Fusing IV

1. FUSER TRAY SUB ASSEMBLY (with 2~30) (same as PL 9.3.2) ..	N/A
2. FUSER TRAY	N/A
3. FUSER TRAY CAP-A	N/A
4. FUSER IN SENSOR	N/A
5. FUSER IN HARNESS	N/A
6. FUSER IN HOLDER	N/A
7. FUSER IN ACTUATOR	N/A
8. FUSER IN SPRING	N/A
9. FUSER BOTTOM COVER	N/A
10. FUSER CHUTE FAN	N/A
11. FUSER TRAY CLAMP	N/A
12. FUSER PAPER GUIDE	N/A
13. HORIZONTAL CHUTE	N/A
14. FUSER COLLAR	N/A
15. INPUT GEAR FT1	N/A
16. INPUT GEAR FT2	N/A
17. INPUT STUD	N/A
18. STUD BEARING FT	N/A
19. INPUT BRACKET FT	N/A
20. FUSER EARTH-A	N/A
21. MINI CLAMP-2	N/A
22. CLEANER CAM GEAR	N/A
23. CLEANER CAM SOLENOID	N/A
24. CLEANER CAM BEARING-F	N/A
25. CLEANER CAM BEARING-R	N/A
26. CLEANER CAM ASSEMBLY	N/A
27. CLEANER CAM PIN	N/A
28. CLEANER CAM	N/A
29. CLEANER CAM GUIDE	N/A
30. CLEANER CAM GUIDE HOLDER	N/A

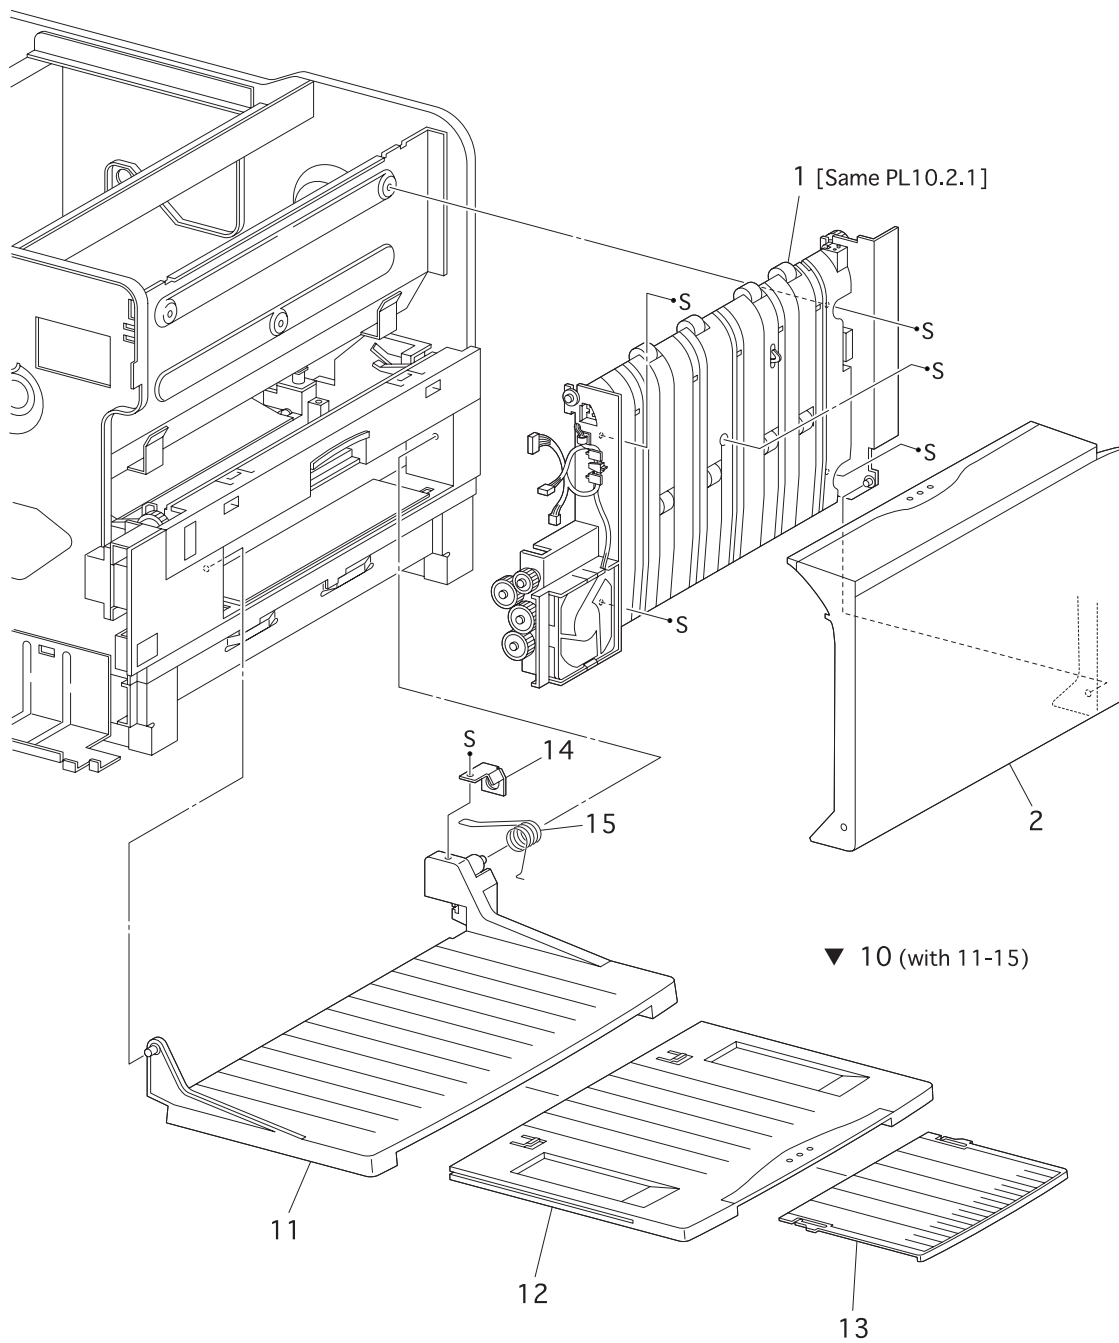
PL10.1 Paper Exit I

PL10.1 Paper Exit 1

1. EXIT LOWER ASSEMBLY (same as PL10.2.1)	P/N 865054K11621
2. EXIT UPPER ASSEMBLY	P/N 865054K06621
10. EXIT TRAY ASSEMBLY (with 11~15)	P/N 865050K27592
11. EXIT TRAY1	N/A
12. EXIT TRAY2	N/A
13. EXIT TRAY3	N/A
14. TRAY BRACKET	N/A
15. TRAY SPRING	N/A

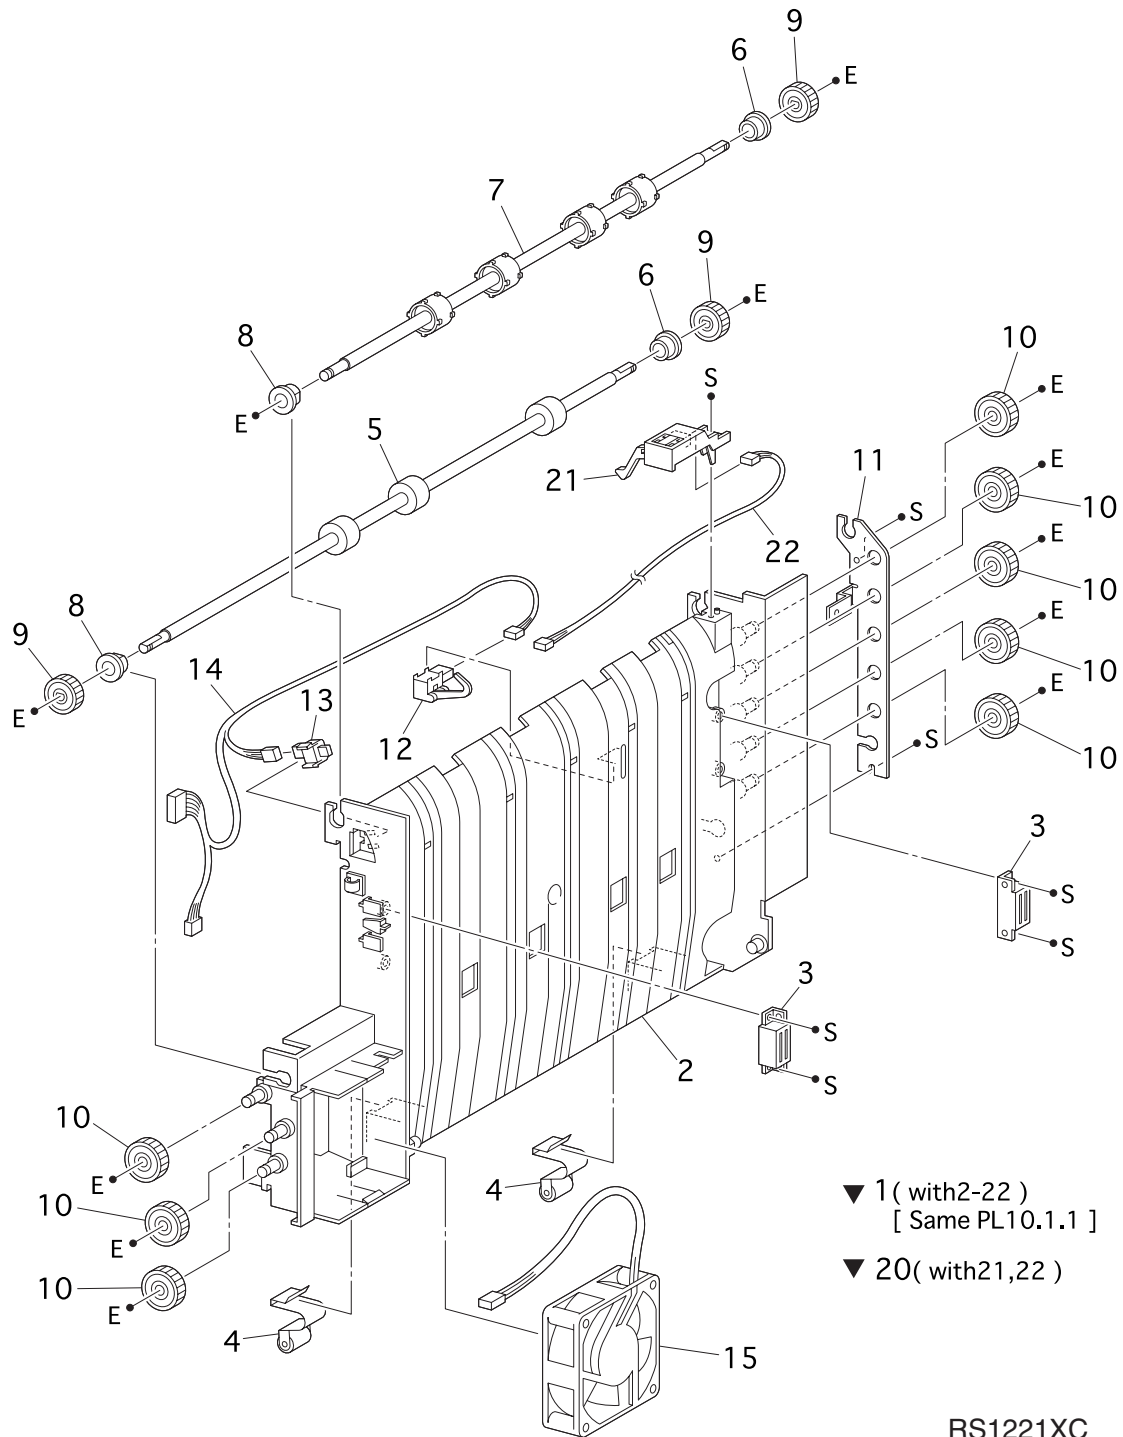
PL10.2 Paper Exit II

1. EXIT LOWER ASSEMBLY (with 2~22) (same as PL 10.1.1)	P/N 865054K11621
2. EXIT LOWER CHUTE.....	N/A
3. CATCH MAGNET	N/A
4. FUSER PINCH ASSEMBLY	N/A
5. EXIT-2 ROLL ASSEMBLY	P/N 865600K68750
6. EXIT FRONT BEARING	N/A
7. EXIT-3 ROLL ASSEMBLY	N/A
8. EXIT REAR BEARING.....	N/A
9. SPUR GEAR	N/A
10. EXIT IDLER GEAR.....	N/A
11. EXIT CHUTE PLATE.....	N/A
12. TOP EXIT SENSOR	P/N 865130E82730
13. EXIT CHUTE SWITCH.....	P/N 865100E93440
14. EXIT HARNESS	N/A
15. FUSER FAN	P/N 865127E81311
20. FULL SENSOR ASSEMBLY (with 21 and 22)	P/N 865130K55990
21. FULL STACK SENSOR	N/A
22. FULL STACK HARNESS	N/A
